SETA Contract Number
F11624-88-D-002
Delivery Order 6K04
CDRL A004

Technical Report - Study/Services
Analysis of PC-2001 NIC Backplane Adapter

18 October 1989
Cargo Movement Operation System (CMOS)

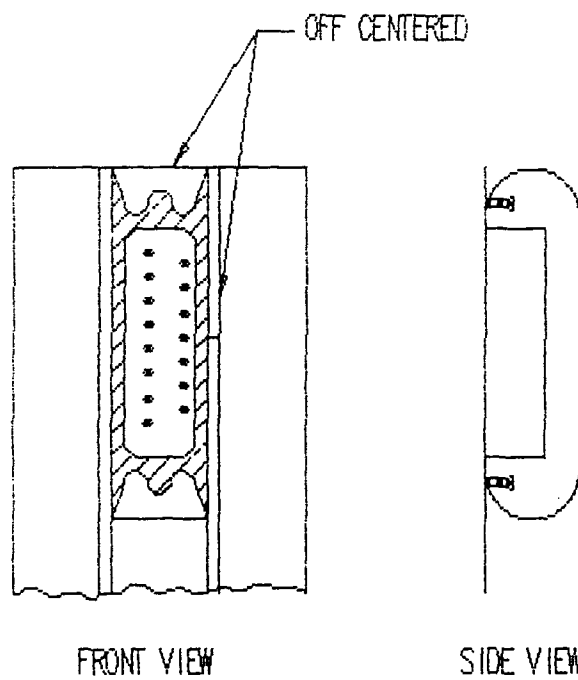
PC-2001 NETWORK INTERFACE CARD

INTRODUCTION: This report describes a deficient engineering design in the Ethernet transceiver drop cable connector on the PC-2001 NIC. (See Attachment 1)

SUMMARY: Problems in the sliding lock and connector mechanism on the PC-2001 NIC (Network Interface Card) can prevent the terminal from accessing the network and can lead to premature failure of the NIC.

ANALYSIS: During the installation of the PC-2001 NIC in the Z-248 microcomputers, we observed that the sliding lock mechanism (see Attachment 1) used to secure the transceiver drop cable seemed to be too wide for the slot in the back of the computer. Closer examination showed the assembly width was not the problem, but rather it was not properly placed on the card's mounting bracket. This connector and lock assembly placement was incorrect on all PC-2001 NICs used in the lab installations. The improper placement prevents the card from being installed squarely on the microcomputer's mounting plate. Since the card cannot be correctly aligned, the board is flexed which can lead to early component or trace failure. Additionally, we observed that the sliding lock mechanism is prevented from working correctly as it binds on the microcomputer's mounting plate. Since the locking mechanism binds, it does not securely hold the transceiver drop cable. In two instances, the drop cable fell out of the assembly under its own weight. Any additional strain simply aggravated the condition.

RECOMMENDATION: This problem can only be corrected by increasing the distance between the actual connector and the NIC component board. The relationship between the NICs connecting bracket and the printed circuit board is correct. Once the actual connector is raised above the printed circuit board, the metal connecting bracket will have to be remounted.
